METLAKATLA PENINSULA LEAD-BASED PAINT INVESTIGATION

FOR THE
METLAKATLA INDIAN COMMUNITY
METLAKATLA, ALASKA

**Prepared by
Ridolfi Engineers Inc.
Seattle, Washington**

June 30, 1998

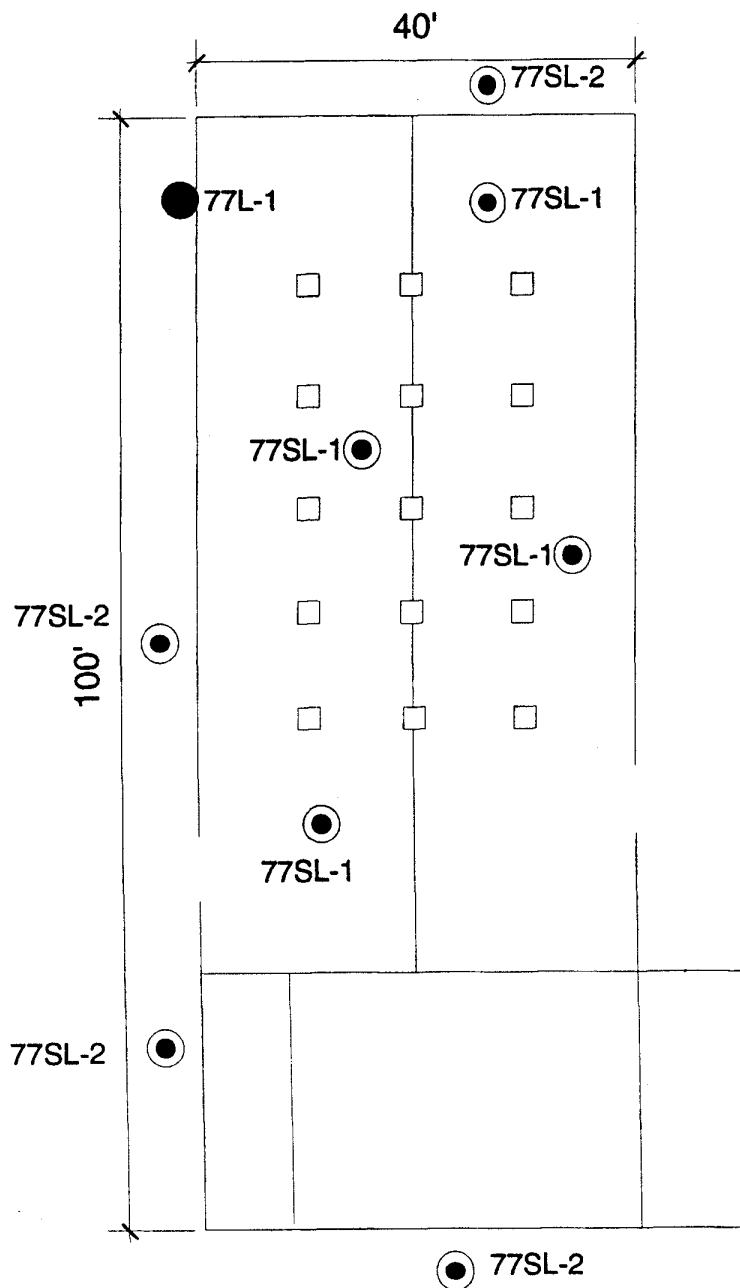
Photograph 77: PNA/WA Terminal

The PNA/WA airline terminal was a 40-foot x 100-foot, single story, wood-frame building. The building had a garage (eastern 5 percent of building) and a former combined passenger lounge and food service and ticketing areas. The terminal building was destroyed by fire (see photograph 77).

Most of the building lies in debris piles near the building foundation. Remove and dispose of this material after asbestos is abated. Stockpile and salvage metal.

Recommendations:
Remove painted debris from site.

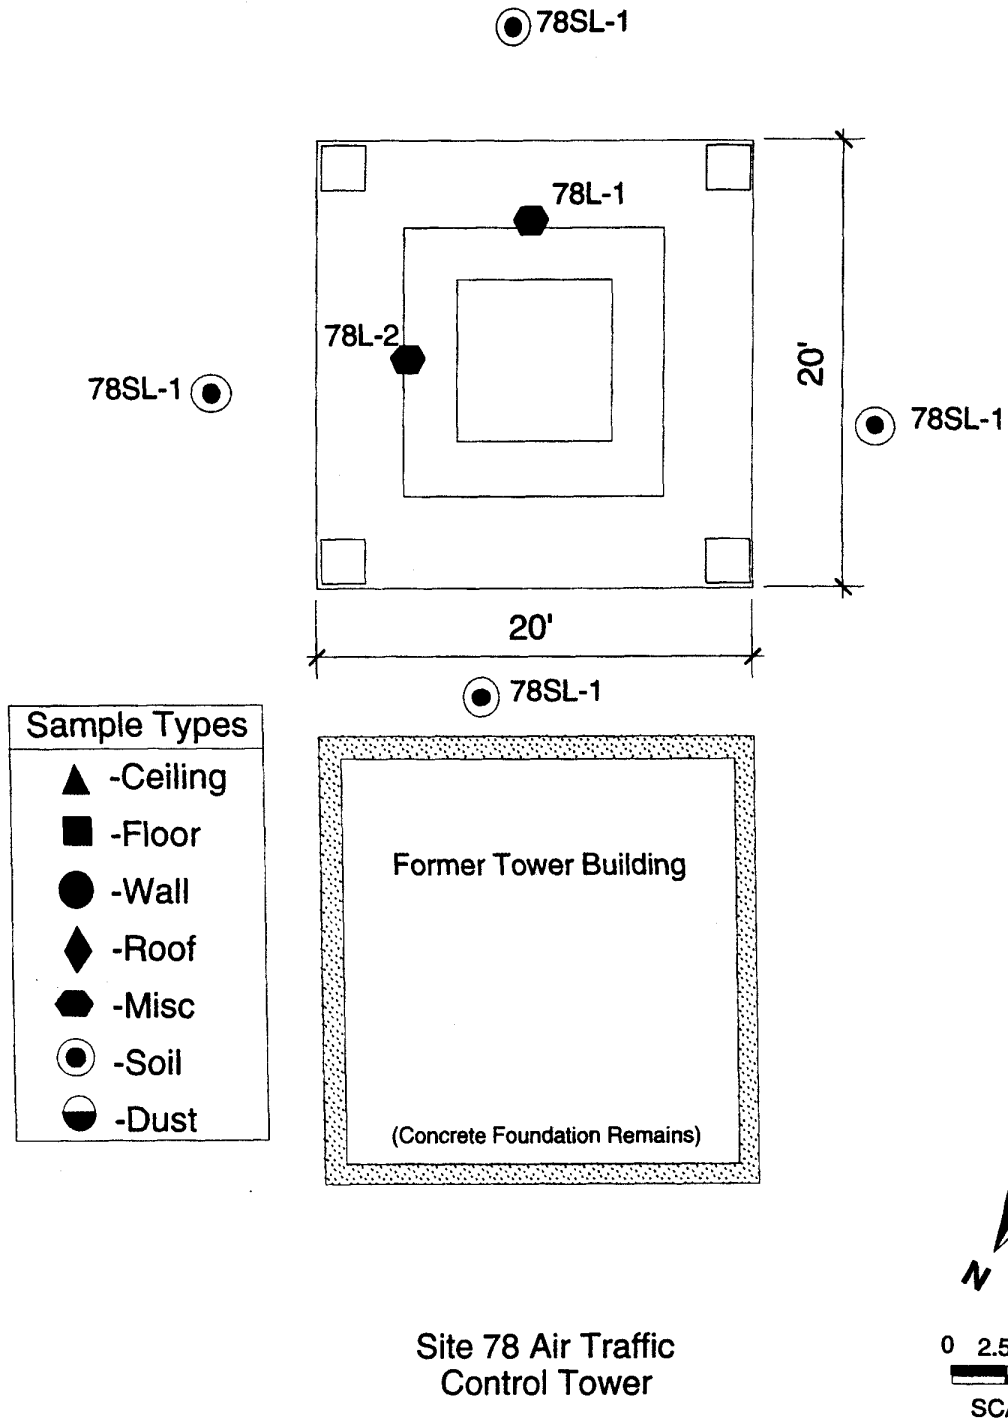
The remains of the air traffic control tower consist of an approximately 60-foot, faded, red-and-white steel tower with a catwalk near its apex (see photograph 78). A 20-foot x 20-foot x 10-foot tall tower building (control room) is on the north side of the tower and adjacent to it. The building/control room has burned down.

Remove Lead Based Paint and repaint structure.
